<b>Title:</b>	Baluns Video Quality Issues	<b>Version:</b>	v1.0	<b>Date:</b>	11/11/16
<b>Product:</b>	Hikvision DS-1H18 Baluns	<b>Page:</b>	1 of 2		
<b>Action Required:</b>	None, Information Only

## Summary

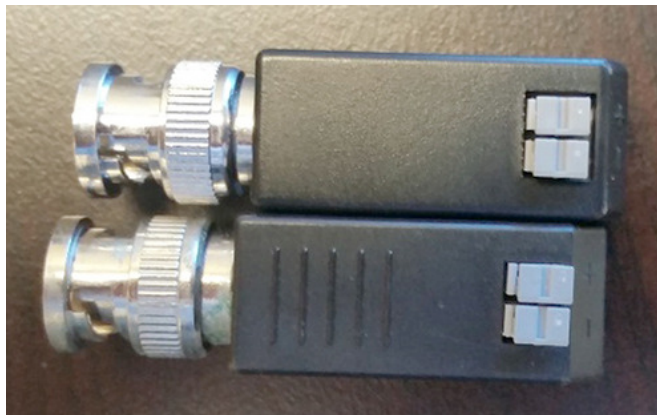
Problems with current production baluns were reported from the field at several sites from around July to October 2016., Issues in video quality included no video, to lines and artifacts. Upon inspection and evaluation, a manufacturing defect was found where the UTP terminals were reverse polarized on the newer inventory. Fortunately, the reverse-polarized units were manufactured beginning in May of 2016 with a new case style, which makes them easy to identify. This Technical Bulletin defines how to identify the balun types and steps to take to avoid video issues. With this issue clearly identified and all steps taken to correct the manufacturing process, we are confident that it has been resolved.

- **Housing** – The older balun has a flat housing. The newer reverse-polarized balun has a ribbed housing.

Figure 1, Old Flat Housing (top). New Ribbed Housing (bottom)

It is only necessary not to mix pairs on the same UTP line. Use only a flat-to-flat housing pair or a ribbed-to-ribbed housing pair when installing them. Using a flat-to-ribbed housing pair will result in video quality issues.

As always, it is important to keep the + and - polarity consistently matched between Balun pairs when installing.

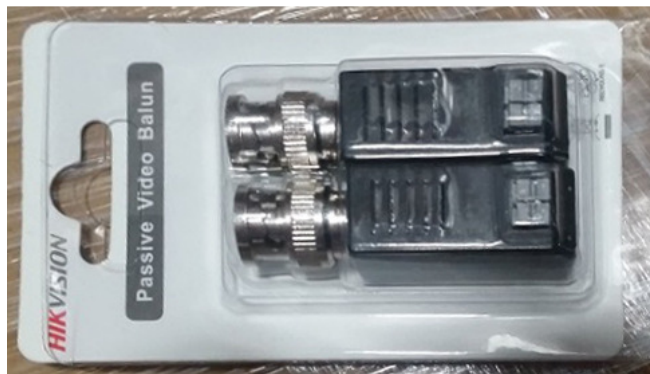
- **Packaging** – The new baluns, with the ribbed housing style, are packaged as shown in Figure 2.

Figure 2, New Baluns Packaging
